Subject: Delivery of Photographs for "12th Street Dump site, Wilmington, DE,"
TS-PIC-20803581S

**Historical Aerial Photo Analysis
12th Street Dump Study Area
Wilmington, Delaware**

November 16, 2007

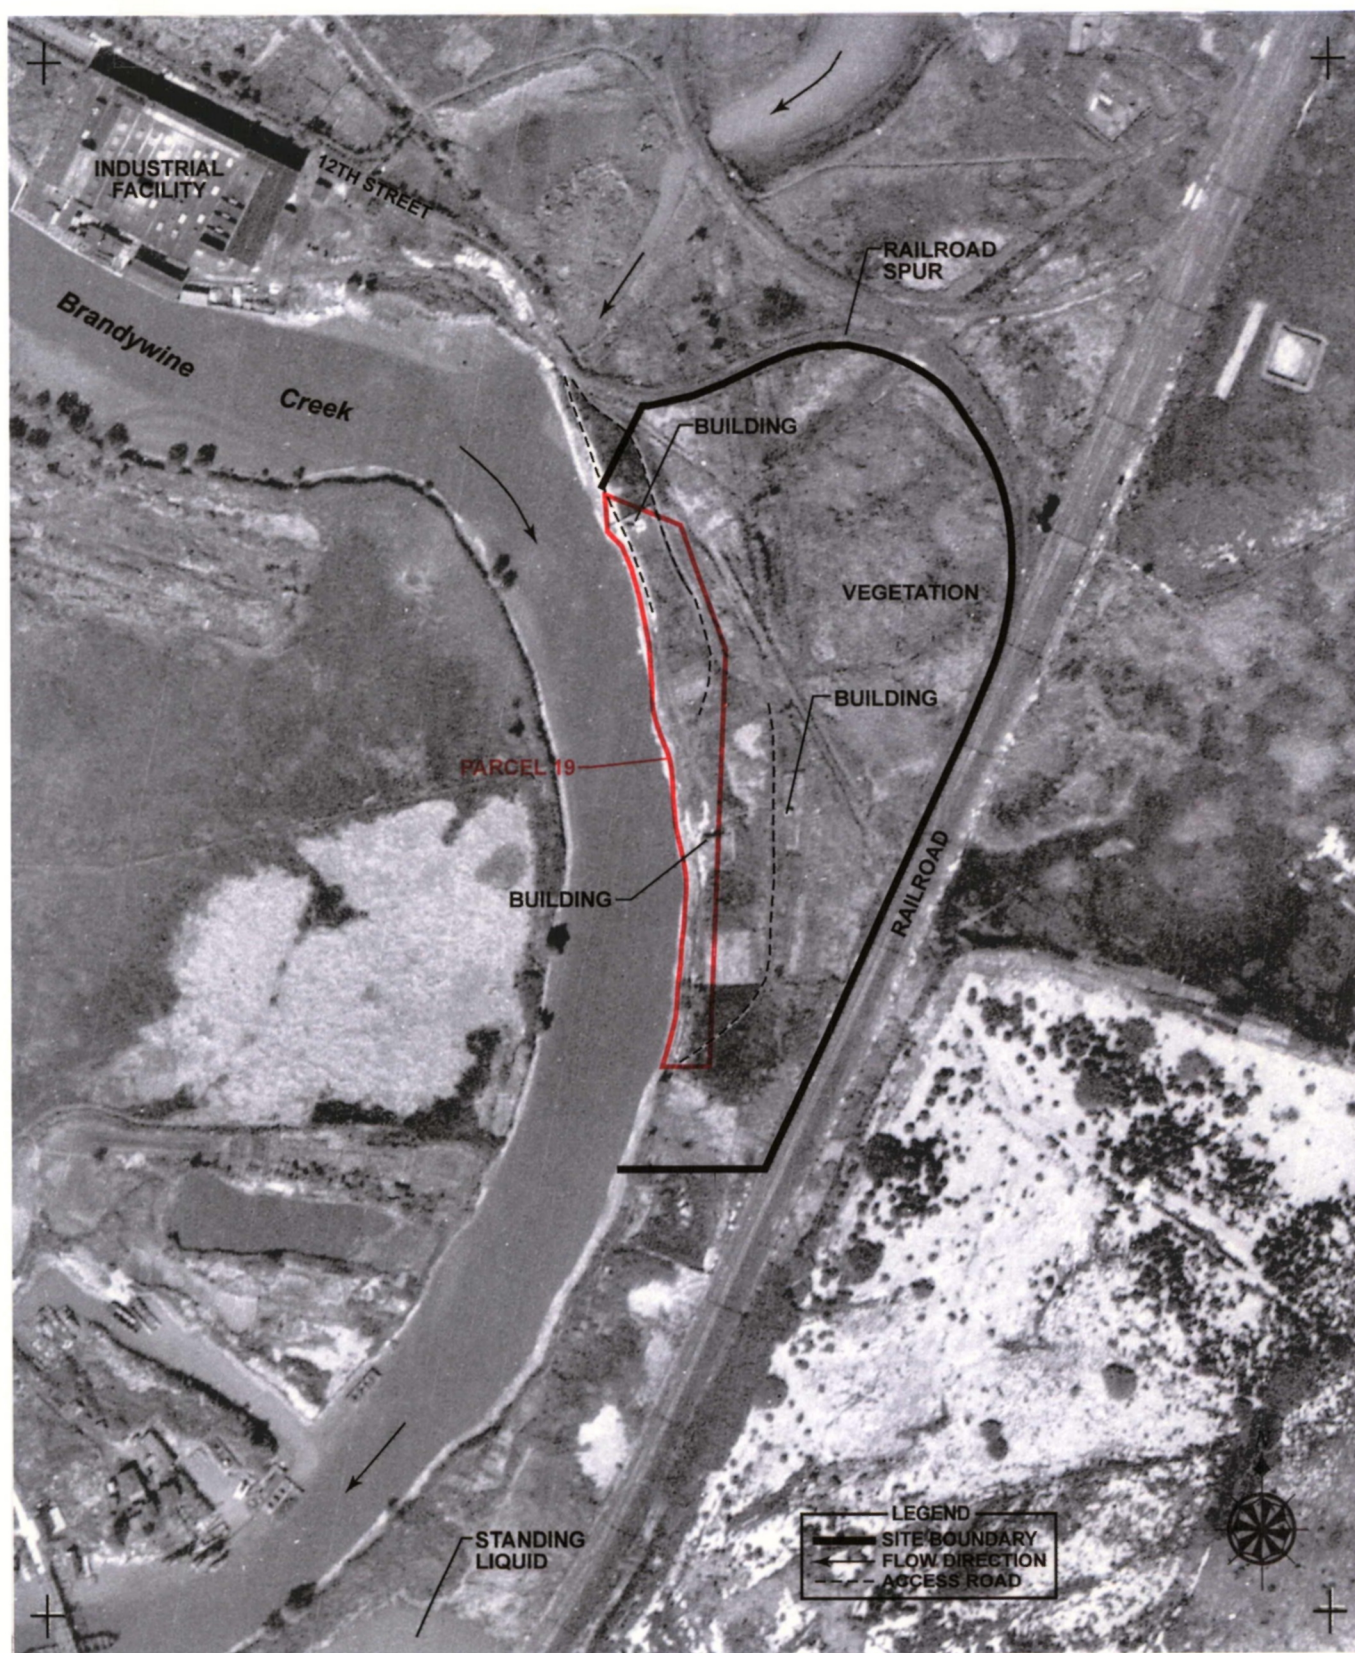
October 16, 1937 (Figure 2)

Figure 2. 12th Street Dump site, October 16, 1937. Approximate scale 1:4,300.

The 12th Street Dump study area generally occupies the area between the railroad tracks located to the east and Brandywine Creek. The high ground on the study area parallels the bank of Brandywine Creek. The high ground slopes gently away from the ~~high ground~~ ^{Brandywine creek} toward the low-lying, vegetated, marshy depression to the east. Much of the high ground is situated approximately 2 meters (7 feet) above the marshy depression. A network of dirt roads provides access onto the study area and the three buildings on it. The two northernmost access roads, which extend southward from 12th Street, cross a bridge over an unnamed tributary of Brandywine Creek before entering the study area. The bridge is shared by the railroad spur that forms the northern border of the study area.

An industrial facility, comprising one large building and numerous smaller buildings, is located northwest of the study area. The aforementioned railroad spur services the industrial facility.

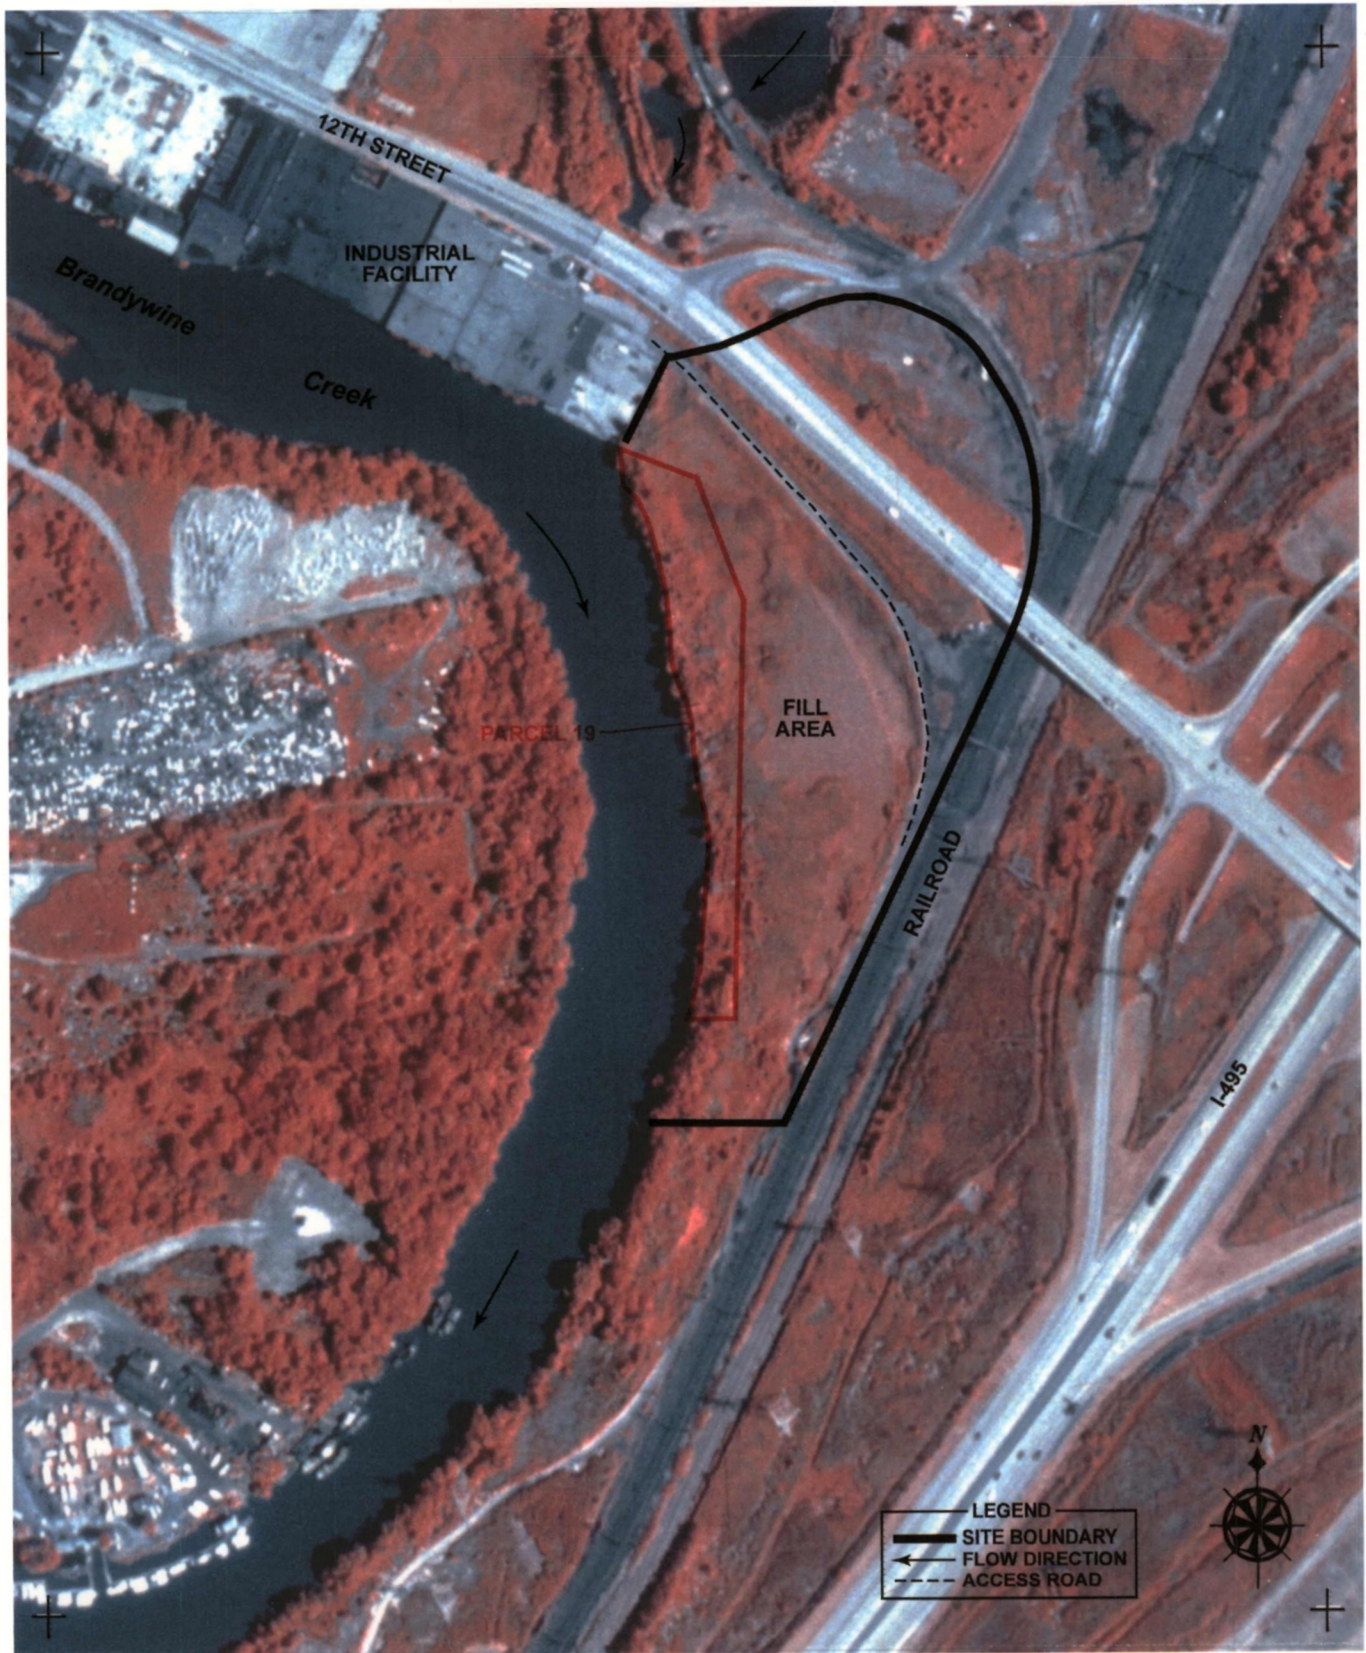
June 10, 1988 (Figure 15)

Figure 15. 12th Street Dump site, June 10, 1988. Approximate scale 1:4,300.

There is no visual evidence that disposal activity has occurred on the study area since 1977. The fill area that covers most of the study area remains relatively unchanged. All but the center section of the study area is covered in brush and trees.

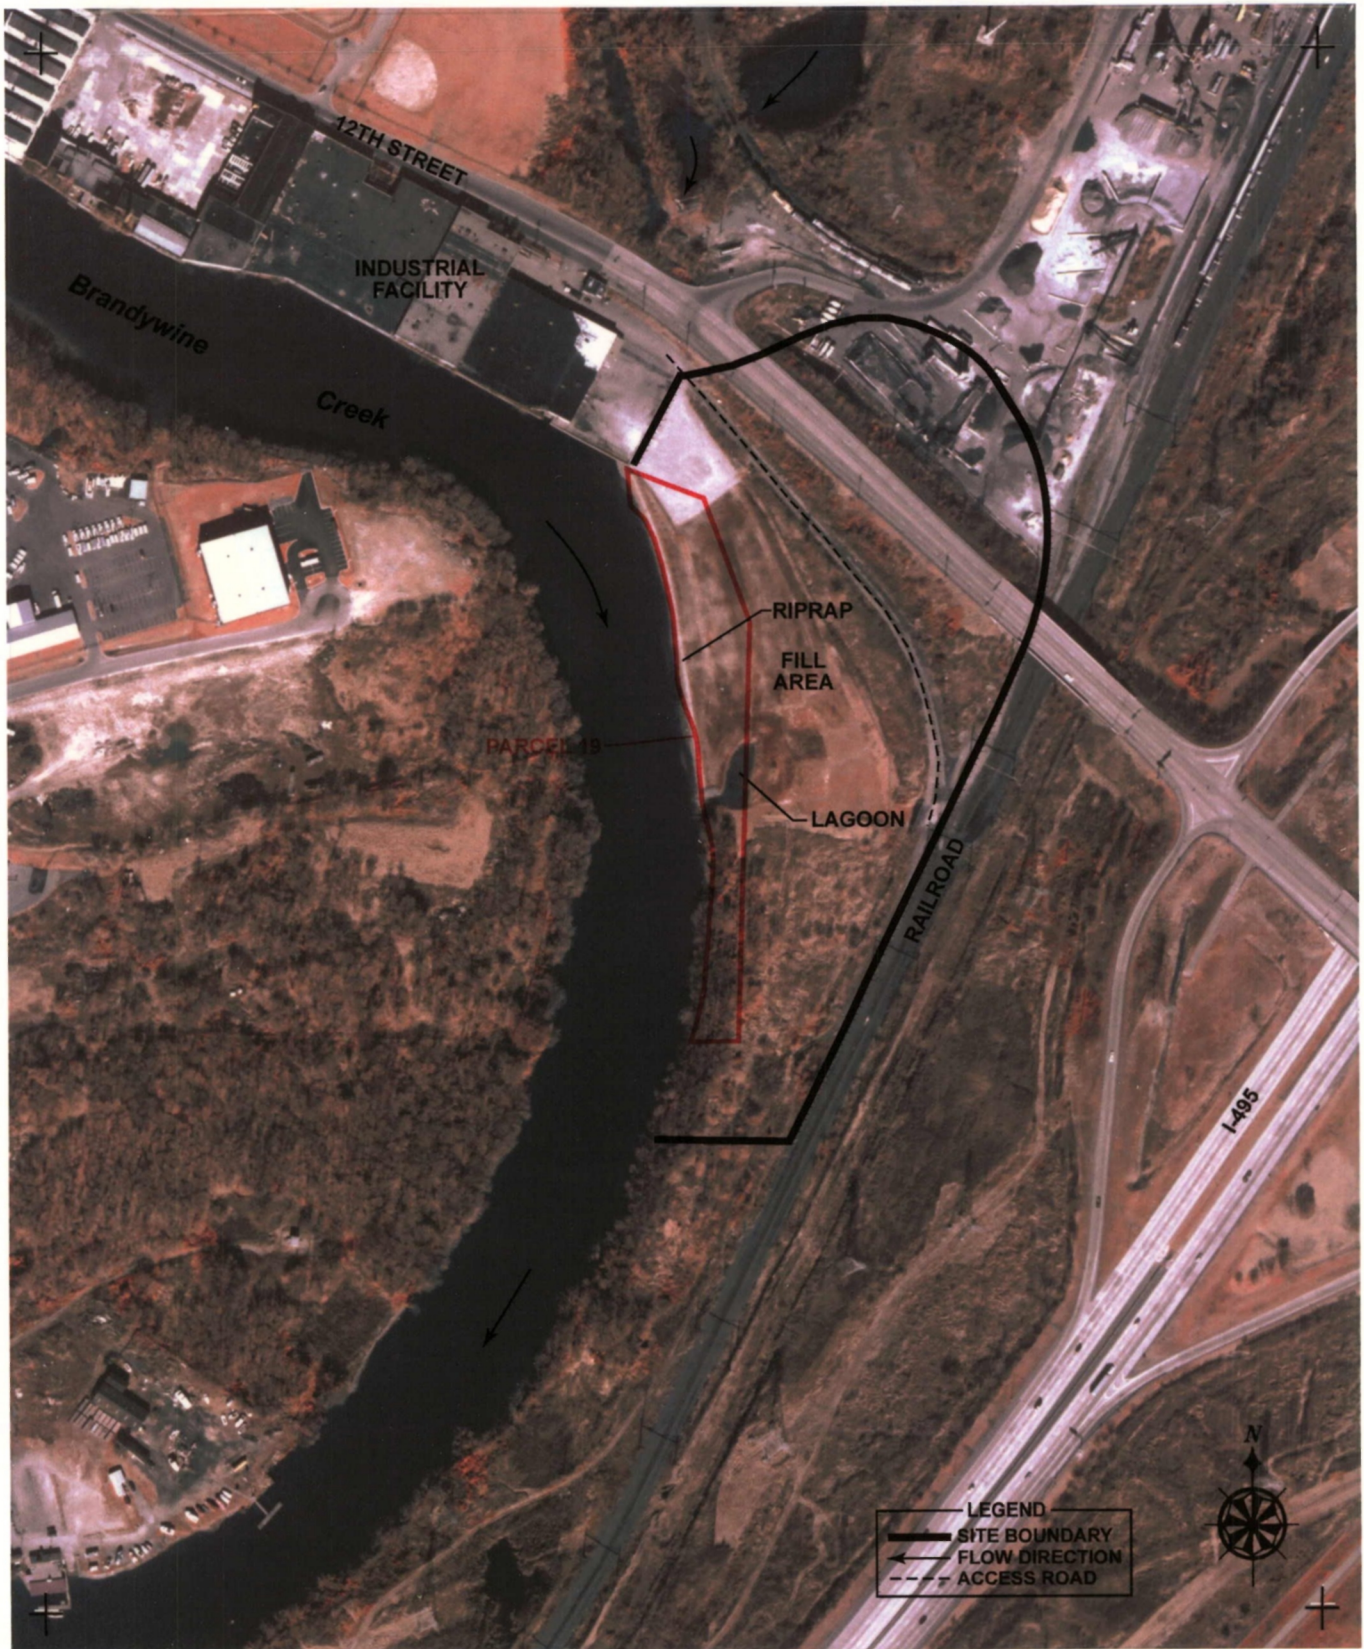
February 24, 2002 (Figure 17)

Figure 17. 12th Street Dump site, February 24, 2002. Approximate scale 1:4,300.

There is no visual evidence that disposal activity has occurred on the study area since 1998. Riprap and a lagoon are now visible along the bank of Brandywine Creek. Trees and brush have been cleared off of the northwest section of the fill area. The open yard in the northwest section of the study area no longer appears to be used as an open storage area.
